**PANGAN-AN ISLAND PV SYSTEM: A CASE STUDY EXAMINING ITS ACTUAL CONDITIONS WITH SIMULATION OF THE EXISTING ELECTRICAL INFRASTRUCTURE USING HOMER LEGACY****Julito B. Anora Jr.<sup>1</sup>, Barry P. Alberca<sup>2</sup> and Joker A. Zeta<sup>3</sup>**<sup>1,2,3</sup>Department of Electrical Engineering CIT University<sup>1</sup>julitoanora@gmail.com, <sup>2</sup>barry16alberca@gmail.com and <sup>3</sup>jokingly.yours.joker@gmail.com**ABSTRACT**

*Keywords: Rural Electrification, Renewable Energy, Pangan-an Island PV System, HOMER Legacy.*

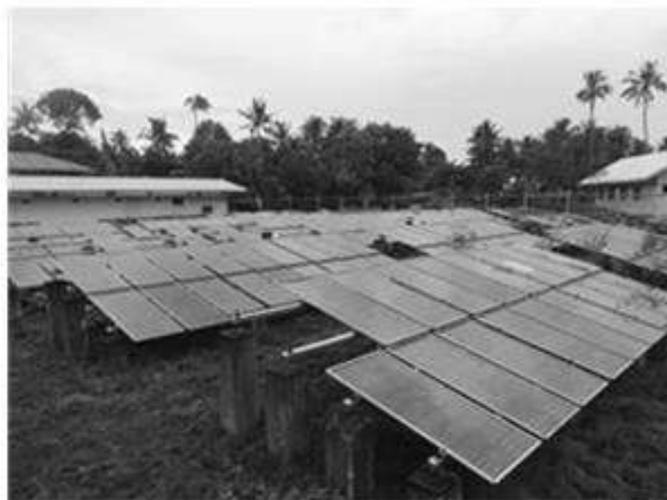
Bushes, weeds, and trees are observed to be growing within the vicinity of the installed solar panels (see Figures 3 and 4). Vegetation is seen growing and most of the plants are covering the solar panels. Though there are still several solar panels installed, most of them are not operating. Panels are seen dumped near the powerhouse (see Figure 5).

**Figure 3.** Condition of the Solar Panels of the PV System

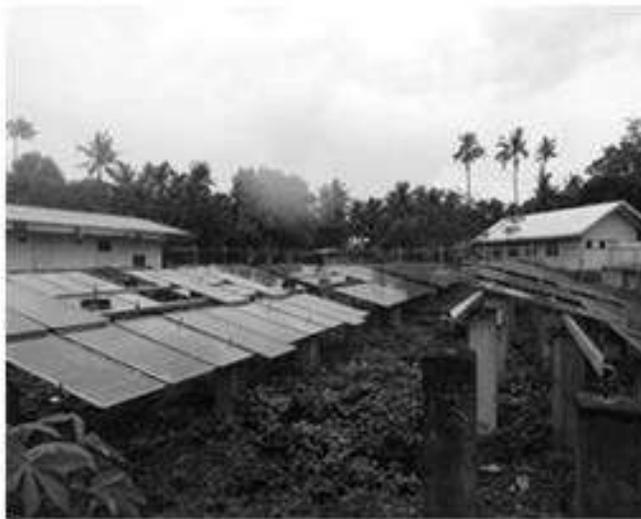
**Figure 4.** Vegetation Growing Near Solar Panels

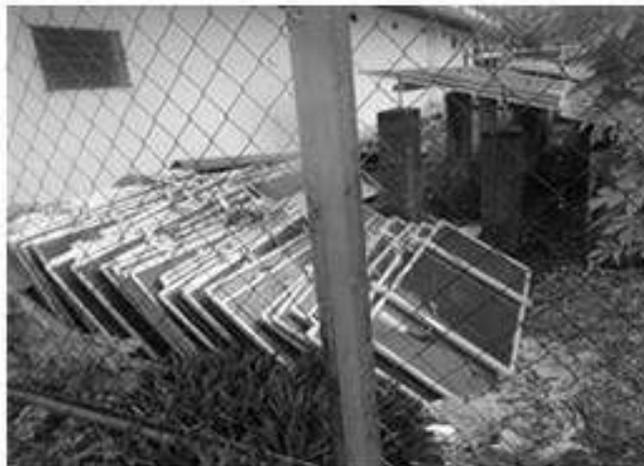
**Figure 5.** Defective panels of Pangan-an Solar Plant
