**PANGAN-AN ISLAND PV SYSTEM: A CASE STUDY EXAMINING ITS ACTUAL CONDITIONS WITH SIMULATION OF THE EXISTING ELECTRICAL INFRASTRUCTURE USING HOMER LEGACY****Julito B. Anora Jr.<sup>1</sup>, Barry P. Alberca<sup>2</sup> and Joker A. Zeta<sup>3</sup>**<sup>1,2,3</sup>Department of Electrical Engineering CIT University<sup>1</sup>julitoanora@gmail.com, <sup>2</sup>barry16alberca@gmail.com and <sup>3</sup>jokingly.yours.joker@gmail.com**ABSTRACT**

*Keywords: Rural Electrification, Renewable Energy, Pangan-an Island PV System, HOMER Legacy.*

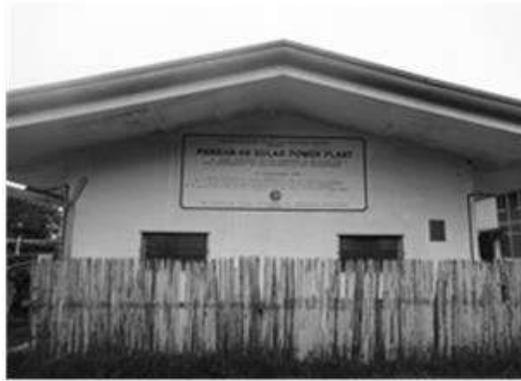
**Figure 1.** Pangan-an Solar Power Plant

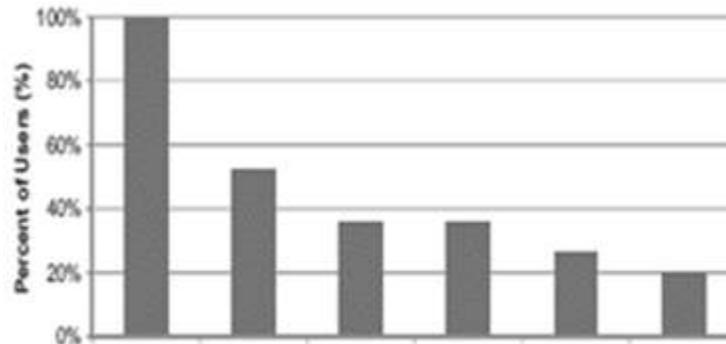
**Figure 6.** Usage of electricity produced from the PV system [10].

To manage the plant maintenance and collection of fees, the Pangan-an Island Community Cooperative for Development (PICCD) was created alongside the solar plant. However according to a study, "the cooperative remained dependent on external technical support while financially the people found it difficult to pay the high cost of the PV service [3]." These statements may be concluded as rational considering the residents who craft shells and earn only about forty-five pesos (Php45.00) per day. However, as reflected in a 2010 survey, 18% of the users consume more than 9 kWh of energy. Further, 20% of the consumers regularly use a DVD player, which explains that they also use the more common appliances and essential devices (light, TV, radio, phone charger, and electric fan) (as shown in Figures 6 and 7).

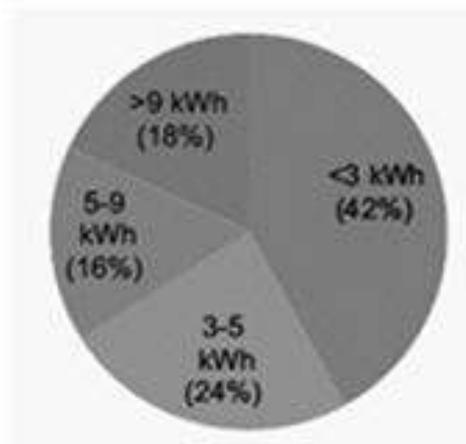
If this fraction of users are large consumers and they have an income sufficient for buying appliances, then they also can pay their electric bills. If their consumptions are the largest, the collections of must also be proportionally large considering this large consuming group.

**Figure 7.** Monthly power consumption of PV system users in kWh [10].

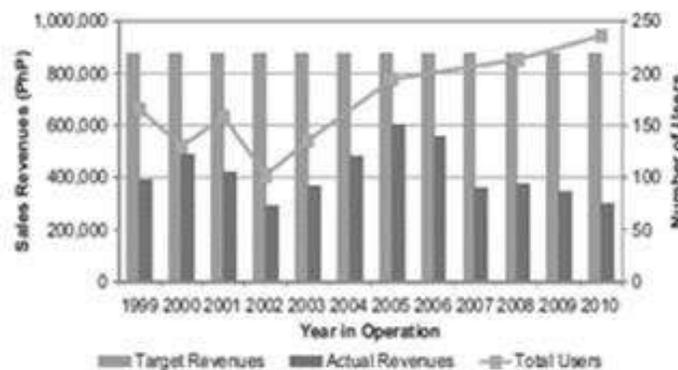
The 2010 survey also collected data on the plant's target and actual revenues. The target revenue is calculated to be the amount sufficient for the maintenance of the power plant. Since the initial year of operations, collections have been much lower than the target. The cooperative points to the low number of connections, figuring out that

the plant is underused. The power costs Php210.00 for the first 9kWh plus Php30.00/kWh for additional consumption back then. In 2003-2006, the rate was reduced to Php110.00 for the first 9kWh and a fraction thereafter to encourage more residents to use modern lighting in place of their kerosene lamps. The number of users, as seen in the graph below, increased at a fast rate. This factor, together with more strict policies in payment deadlines increased the collections as well, but it still didn't hit the target. In 2007, the cost was increased to Php15.00/kWh, but the collections just dropped as the plant's efficiency was also dropping fast. From then on, the plant was unable to service the needs of consumers, resulting in even lower revenues.

Looking into the scenario as a whole, the PV plant was seriously mismanaged by PICCD, technically and financially. During the recent visit, for instance, it was discovered that the engineer-in-charge is always not around and does not have a defined duty schedule for evaluating the plant's performance. The whole plant is entrusted to only one caretaker who also was not around. This is a clear manifestation that the cooperative's management is unconcerned about the plant's deterioration. The defective meter mentioned in the first paragraph is also proof that the cooperative is not monitoring how damaged the plant is, or if there is still consistency between the produced energy and the collected payments.

**Figure 8.** Yearly Electricity Sales (target and actual) and the number of users connected to PV system [10].

There are two recommendations related to this concern: First, review the contract between the cooperative and the technical staff, especially the engineer-in-charge, and push necessary changes that will result in the plant's improvement; and second, technically train additional residents on the solar plant's basic troubleshooting and maintenance. The second will need external assistance, but it will near the plant into an independent and consistent operation.

PICCD needs a third-party auditing body to evaluate its existing policies in payment schemes for its consumers, budget allocation, and service conditions. The cooperative had failed from the very beginning in its Php210.00 minimum payment policy for they haven't considered that many of the residents will only subscribe for lighting purposes. With the help of an auditing body, they can come up with a new policy that will be fair for both micro and large consumers. The tighter payment collection practice, then, can be implemented with minimum negative feedback. Everybody will be more supportive of improving the health of the organization, and thus the performance of the solar plant.

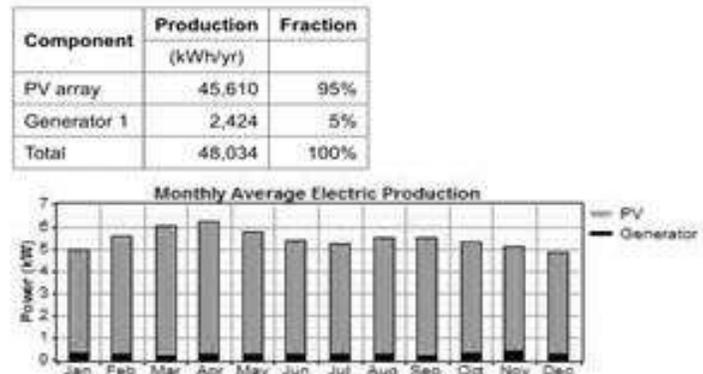
In a series of simulation runs, Figure 11 shows the optimized results. As explained, the first years of implementation showed that the PV performance is at its highest. The renewable energy fraction of PV is at 95% with a yearly power output of 45.6 kWh. The generator contributes 5% of the total energy mix with a share of 2.42 kWh. The monthly average energy production is shown to be highest in months from March to April, the summer time in the Philippines. The average solar irradiance at this season is at 1000 W/m<sup>2</sup> or even higher effective 4.5-5 hours a day.

**Figure 11.** Electrical Component of the System report by the first Homer Simulation

In addition, it can be noticed that the share of the production of the PV array is acceptable. This is because while the majority of the contribution comes from the PV array, the diesel generator still contributes enough for the supply of electricity in the community. From a broader perspective, the energy share of the generator at 5% may result in a minimized fuel consumption which may result in a reduced environmental impact.

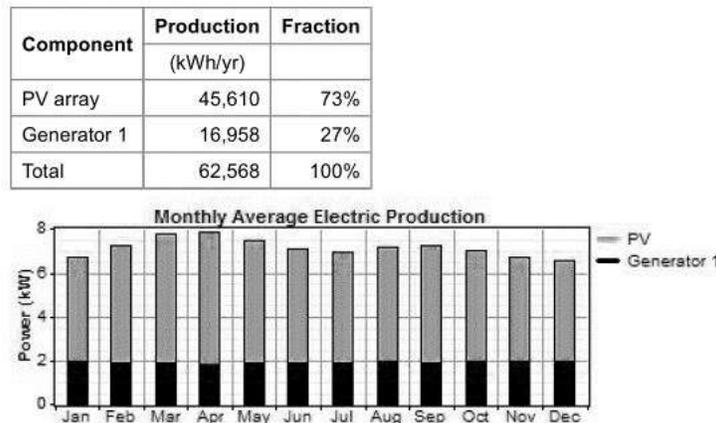
In the next five years of PV operation, it is already considered that the performance of the PV system also deteriorates. In Table 2, 115 out of 504 panels and 36 out of 118 batteries are found to be defective which would mean an estimated gradual decrease of 22.82% of output power of the overall PV system. Clearly, the simulation in Figure 13 shows that the PV system is estimated to be sharing 73% of the energy mix.

**Figure 13.** The electrical component of the System report of the second Homer Simulation

In the second simulation, the PV array indicates a performance decline sharing the energy mix at 73%. This means that a sudden increase in demand for the generator is expected to fill in the gaps in the PV system with a share of 27%. The original capacity of the PV system at 40 kW may suffer a decline in energy generation. As a result, the supply of energy may no longer meet the demand of the locals in the next five or ten years of operation. In the analysis, other contributing factors may aggravate the situation. First, the population may increase and second, the loads/appliances may also increase noting the economic vibrancy that the PV system brought in the first 5 years of implementation.

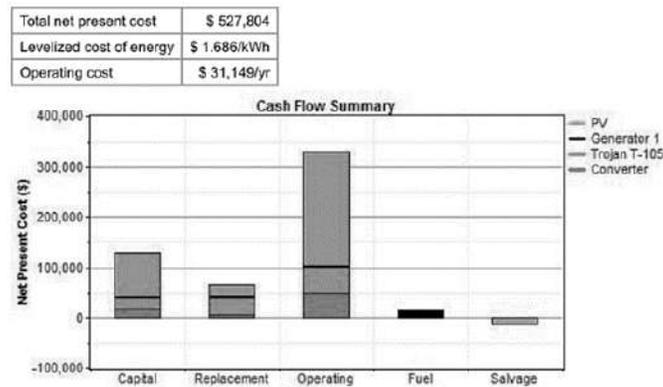
From the economic perspective, the Levelized Cost of Energy (LCOE) of the first simulation yielded \$1.686/kWh while the second run yielded an LCOE of \$2.405/kWh. This means that with a greater share of renewable sources, the LCOE will be cheaper (see Figures 15 and 16).

Figure 15. Cost Summary of the first Simulation Results

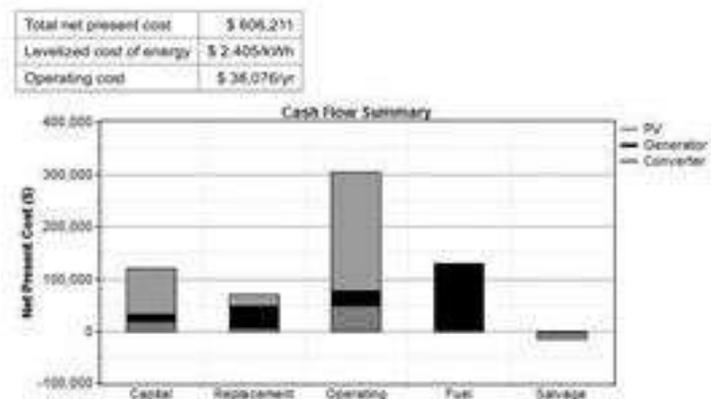
Figure 16. Cost Summary of the Second Simulation Results
